SLIDE INVESTIGATION

September 1, 1976

ERFO 781(1)
03-G13-Forest Highway 7
(Mendocino Pass Road)
Lab. Auth. 662797

REPORT OF SLIDE INVESTIGATION
AND GEOLOGICAL REVIEW NEAR STATION 273+
03-GLE-FOREST HIGHWAY 7
WEST OF WILLOWS, CALIFORNIA

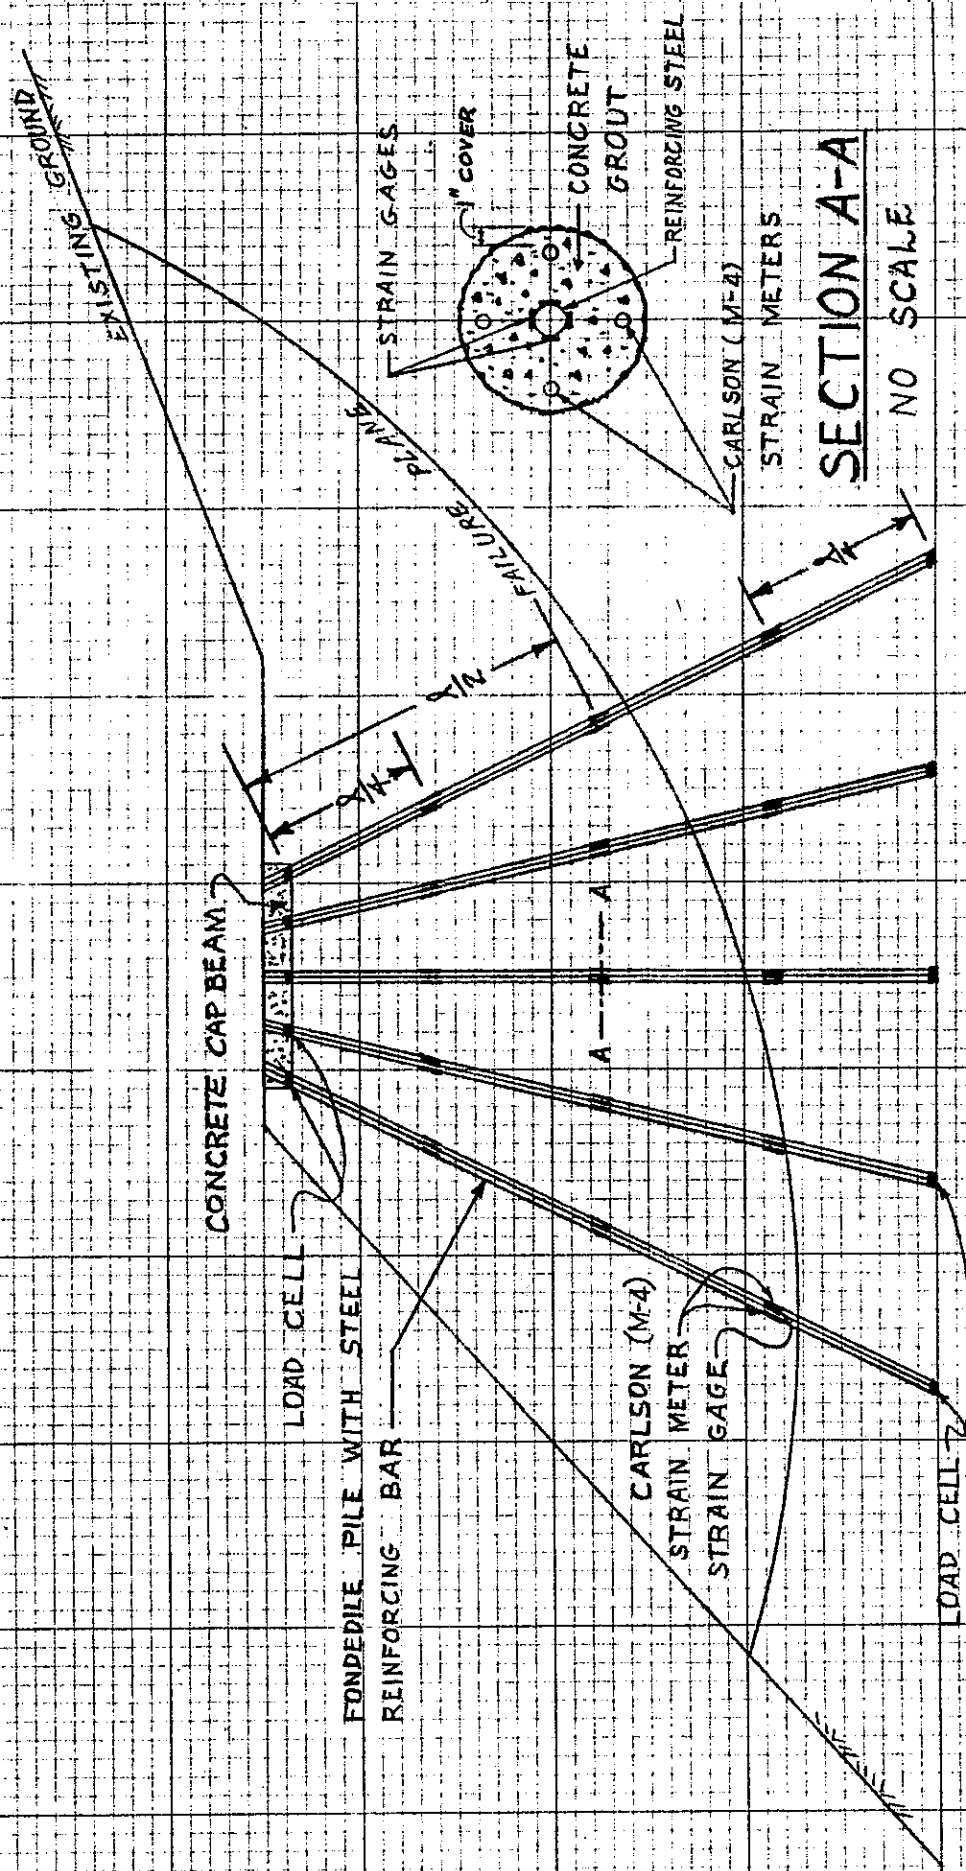
SCHEMATIC OF PROPOSED INSTRUMENTATION FOR FIVE PILES

The proposed instrumentation plan for construction control consists of instrumenting five (5) preselected piles and providing

additional slope indicator monitoring locations and both horizontal and vertical survey points. Four (4) strain gages will be installed on the circumference at the 90 degree points on the reinforcing steel bar of each test pile at three elevation levels. Carlson M-4 Strain Meters will also be installed at the same levels and locations by means of a special jig attached to the reinforcing bar. These special jigs will hold the strain meters in position at a distance sufficient to provide approximately 1-inch of concrete cover between the outer nominal pile diameter and the strain meter. Load cells will also be welded to the bottom of each reinforcing bar of the five (5) test piles. The instrumented bars will be installed prior to concrete placement.

Load cells will be installed at the top of each instrumented reinforcing bar by means of a special attachment and grouted into the cap beam. All instrumentation wires will be routed to an instrumentation readout facility. A schematic of the proposed instrumentation plan is attached.

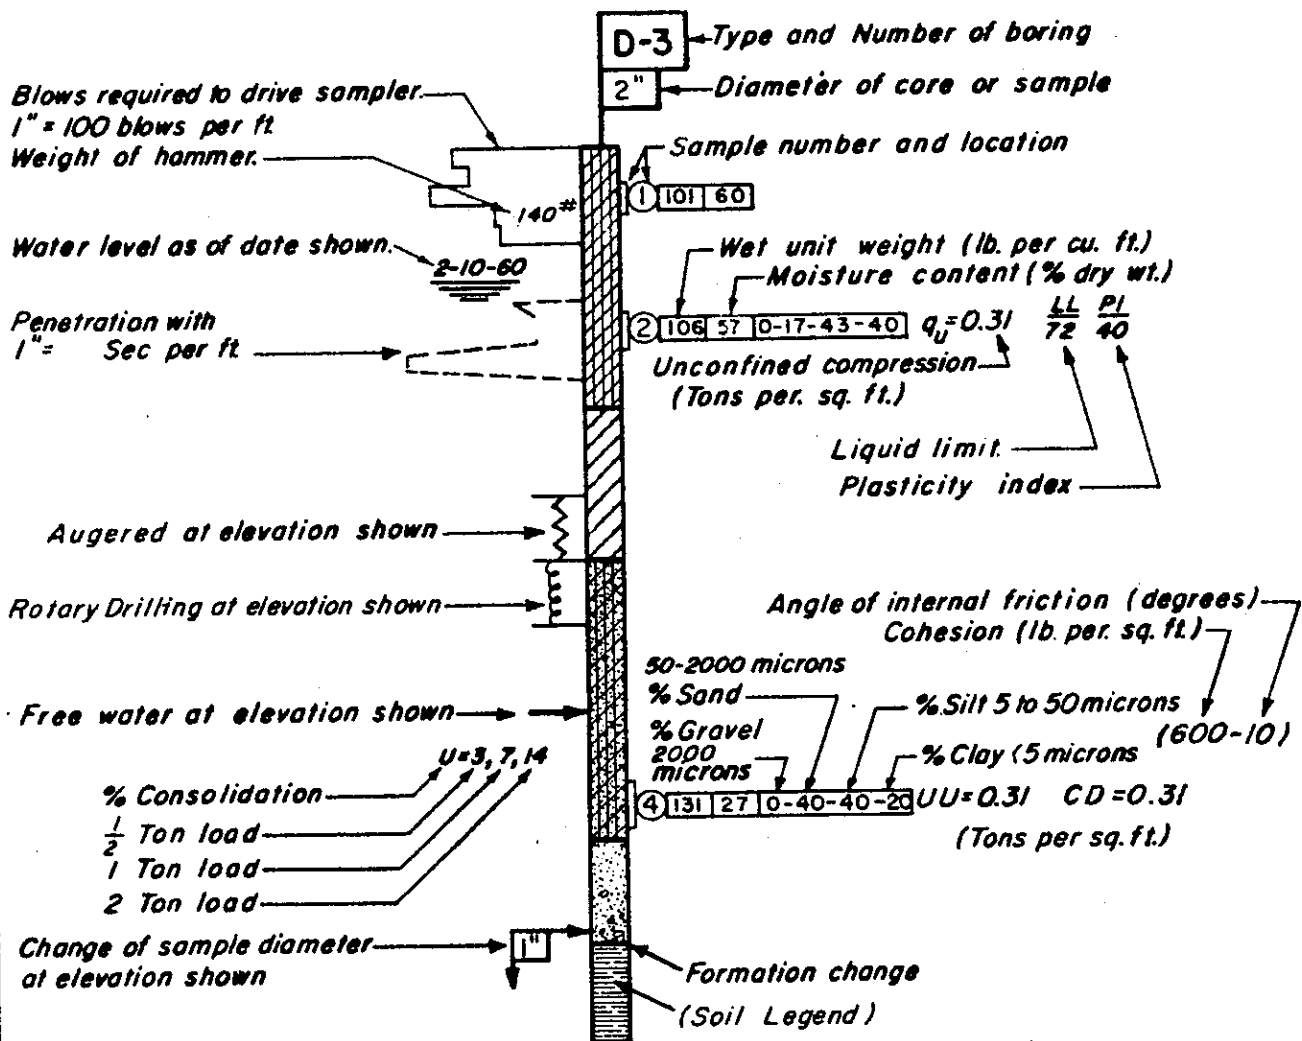
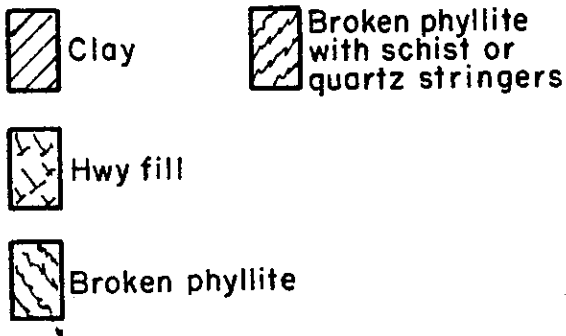
CROSS-SECTION & PROFILE SHEETS

A description of the materials encountered during the drilling operation is shown on the boring profiles (Sheets 1 and 4). Two soft, highly sheared, clayey gouge-like zones were noted at 13 and 45 ft. in boring D-1 and are thought to represent planes along which movement has occurred.
